> Indicative fire resistance test utilising the test methodology given in: BS 476 Part 21 : 1987 BS EN 1363-1 : 2020

Prepared for: Hoody Speaker Hoods Ltd 2 Lakeview Stables, Lower St. Clere, Kemsing, Sevenoaks TN15 6NL

Test Report Number 20730

Indicative fire resistance test for Hoody Speakers Hoods Ltd

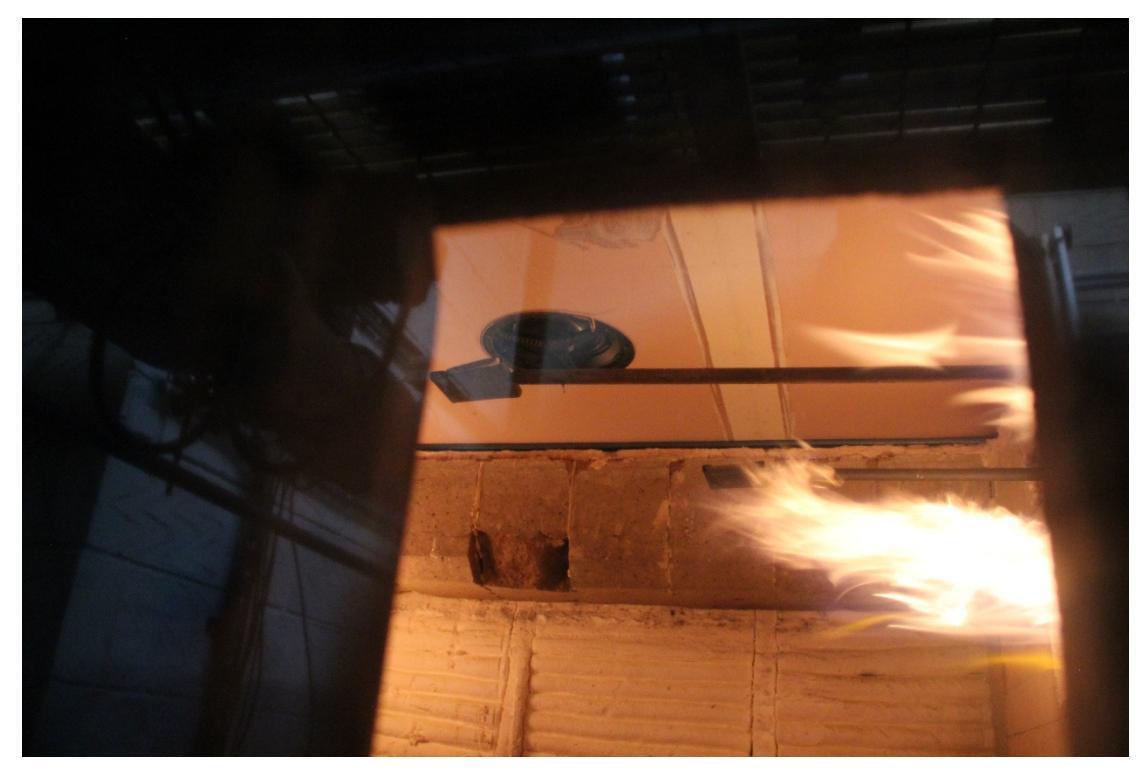
Photo 5 – 1 minute into test on exposed side where the magnetic speaker covers have fallen

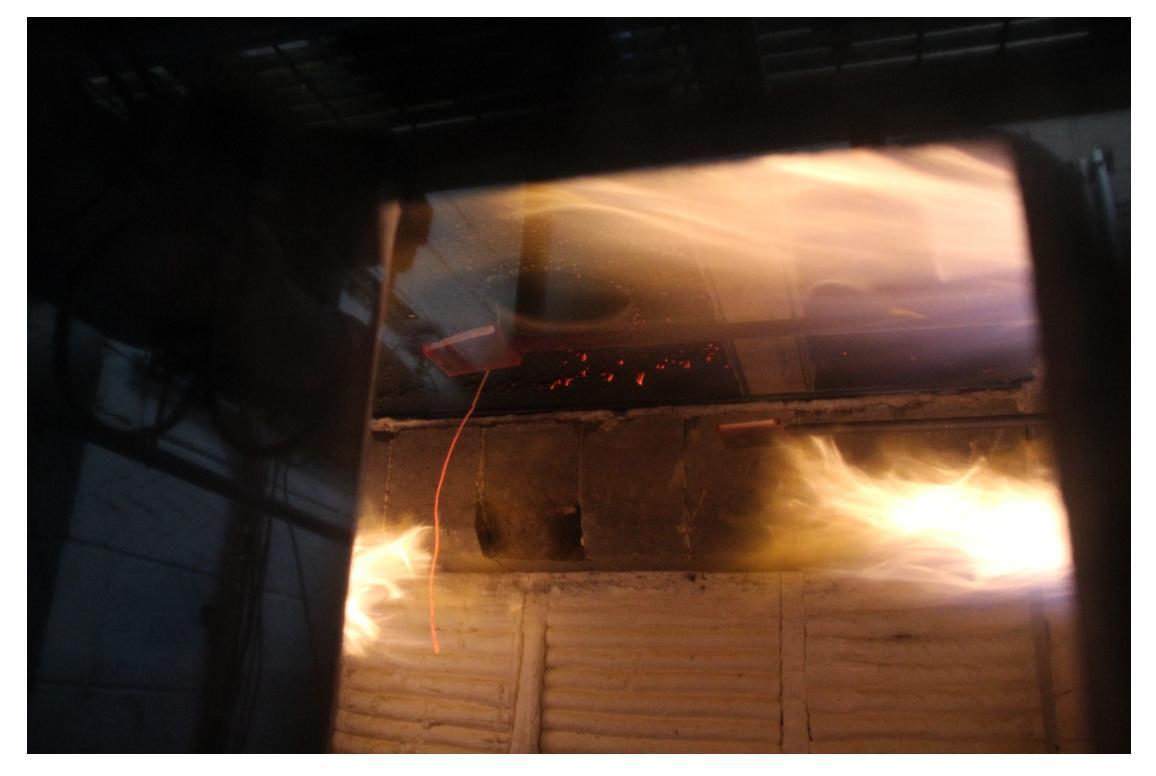
Photo 6 – 2 minutes into test on exposed side where the speakers have fallen

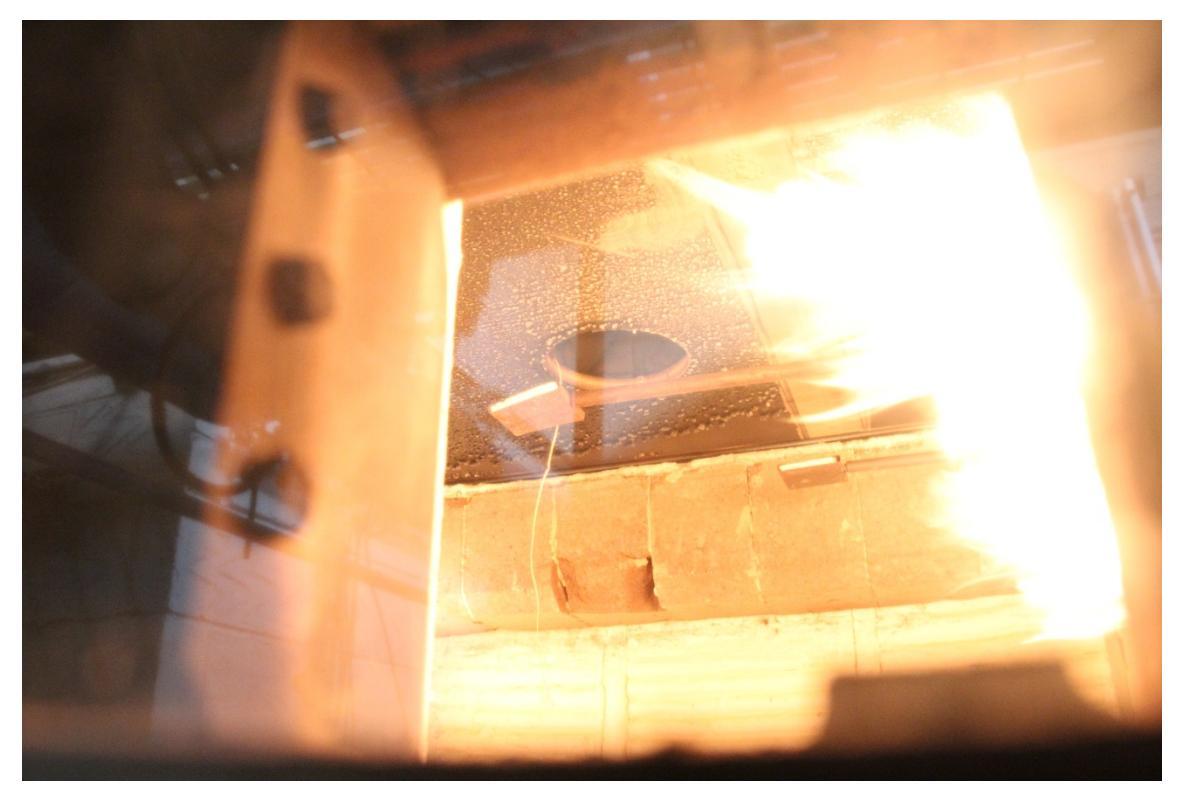
Photo 7 – 5 minutes into test on exposed side, the Hoody fireproof covers are still intact

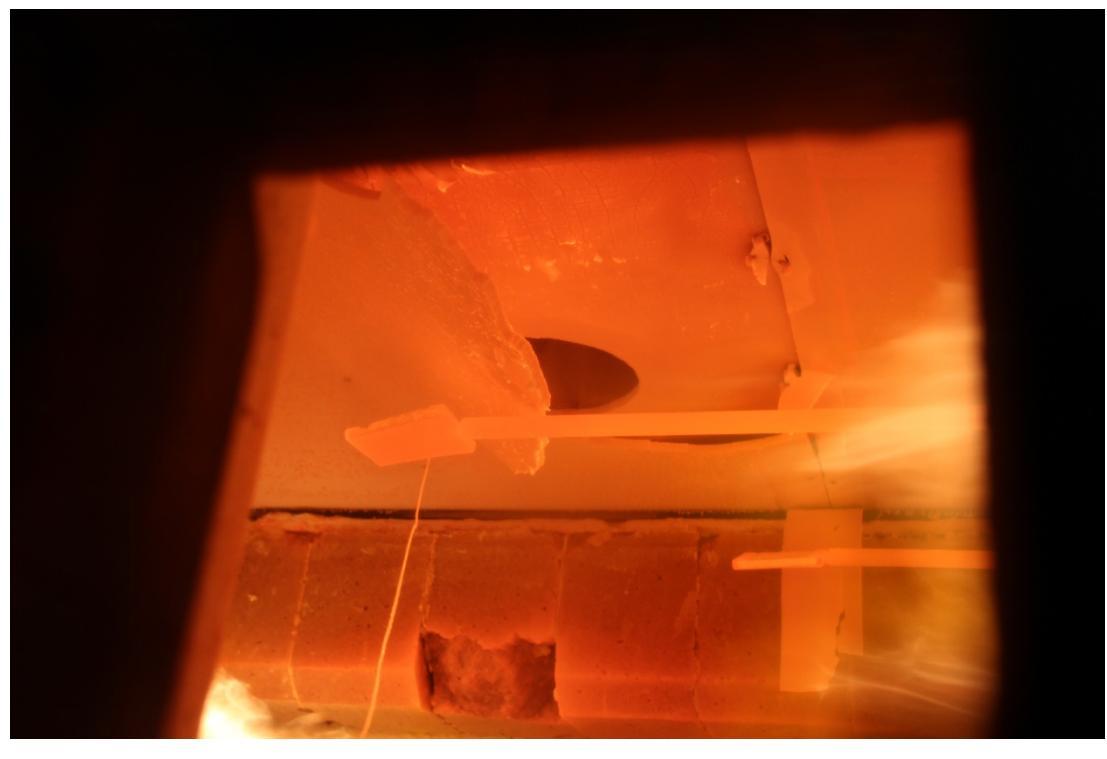
Photo 11 – 55 minutes into test on exposed side

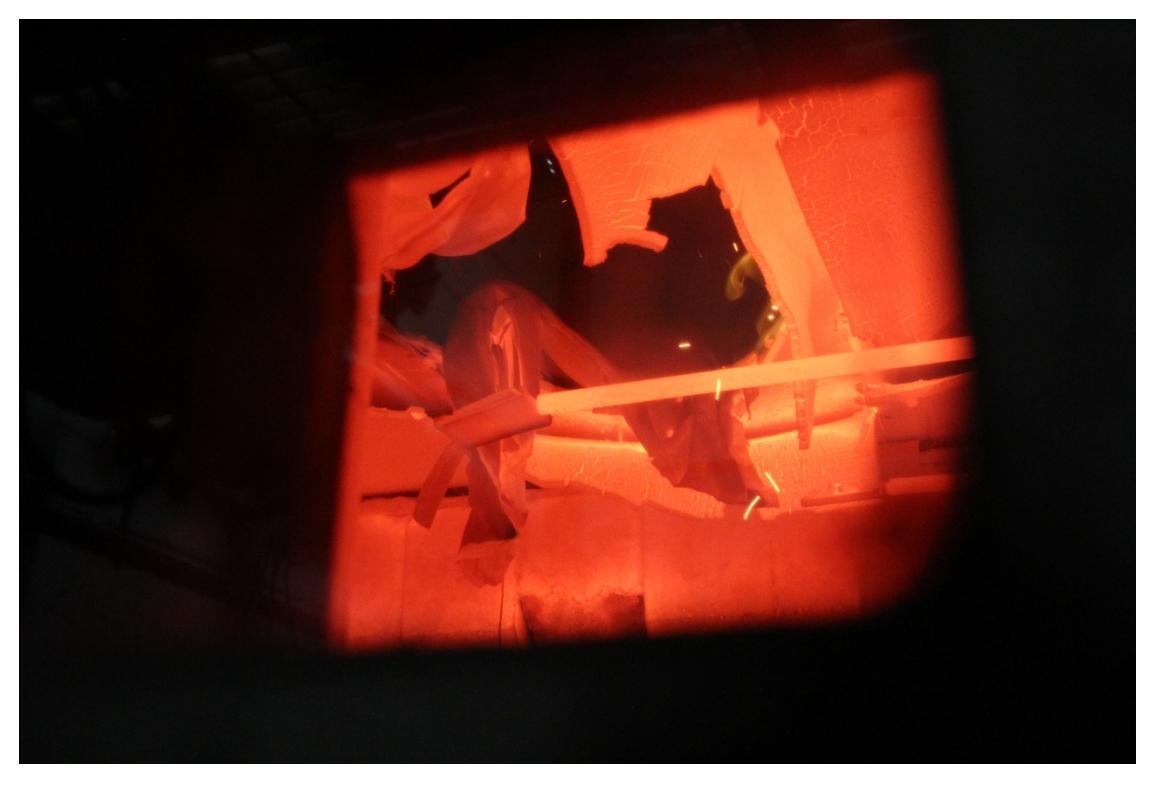
Photo 12 – 64 minutes into test on exposed side. Test stopped.
